Episodes of aircraft icing during ARMEX phase-I

R. P. SHIVHARE

ABSTRACT. In-flight icing is one of the major weather hazards to aviation. During ARMEX Phase-I, there were three occasions out of twenty sorties when in-flight icing was encountered while flying over Arabian Sea in the Russian made transport aircraft AN-32. The icing episodes were studied *vis-à-vis* the prevailing synoptic situations and the convective cloud features. It was found that the aircraft was flying in the vicinity of convective cells associated with considerable horizontal wind shear. The temperature at the flight level was observed to vary from -6 to -8° C. The presence of large amount of supercooled water droplets can be assumed to be associated with the active and intense convection that is usually found under the active monsoon conditions.

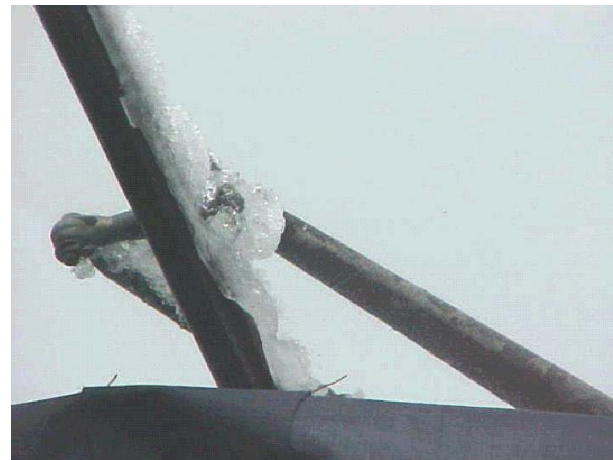
Fig. 2. Icing on the wiper of the front screen of the aircraft

PHOTOGRAPH OF ICING ON COCKPIT WINDOW
Date/Time : 18 Jun 2002/1313 IST Altitude : 20000 Feet
Location: BETWEEN POINT A AND GOA (16.24/72.27)

Discussion – The map depicting the track of the aircraft and the position where icing was encountered is shown in Fig. 1. The icing was encountered at about 300 km from Goa at an altitude of 17,000 ft. The aircraft was flying in between the clouds and sky condition was overcast. The icing took place on the wiper of the front screen of the aircraft (Fig. 2). The icing was mostly glazed. The activated deicing equipment was unable to prevent the icing, indicating that probably a large number of supercooled water droplets were prevailing at the flight level. The heating provided by the deicing equipment was unable to raise the temperature of the aircraft screen to above zero degree resulting in icing. The METEOSAT cloud imagery (VIS/IR) at 0700 UTC indicated very intense convection over the area (Fig. 3). The airborne aircraft radar also showed cloud

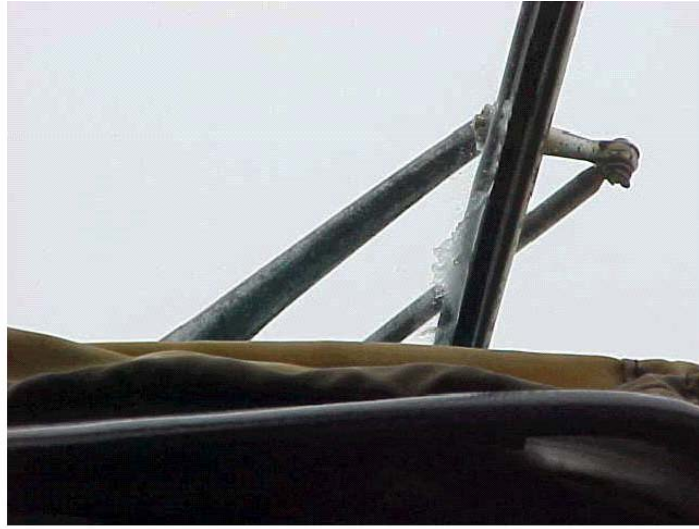
Fig. 5. Photograph showing the icing on cockpit window

PHOTOGRAPH OF ICING ON COCKPIT WINDOW
Date/Time : 26 Jun 02/1302 IST Altitude : 20000 feet
Location : BETWEEN POINT A AND GOA (16.46/71.58)

Discussion – Like in the previous case, this time too, at the time the aircraft passing through in the vicinity of the convective cells, the aircraft experienced the icing (Fig. 5). During the episode the aircraft was in between the clouds and sky condition was overcast. The map depicting the track of the aircraft and position where icing was encountered (Fig. 4) shows that the episode occurred off Goa coast. In satellite imagery (IR) of 0700 UTC, the intensive cloud mass associated with the synoptic system extending up to NE Arabian Sea, was seen over entire west coast and the adjoining Arabian Sea (Fig. 6).
